Stripped Down UV30 Pump

It took 9 years of continuous work before overhauling

Installed in 2000, one UV30 for aluminium can production belongs to the first generation of air cooled, large capacity vacuum pumps. Working 24/7, this machine deserved a full check in order to return to work for the next decade.

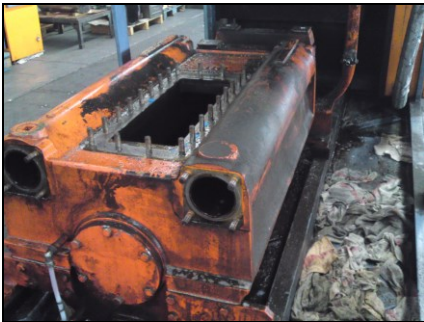
When looking at the pumps, after 71.000 h of work, especially the inside, we can hardly recognize items by the colour, as the cooling fans run constantly and suck cooling air into the pump cabin to refresh the components dissipating heat. It is therefore common to have a considerable "cleaning" work to do before even seeing, being able to observe and analyze single parts.

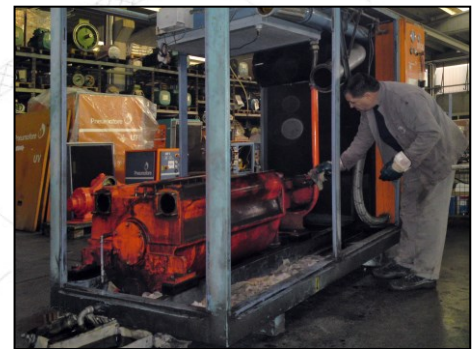
UV30 dismantling and cleaning

The vanes of the UV pumps do not need replacement if the lubricant used is the correct one, if the two bearings of the rotary vane air end are regularly maintained with grease, if the oil filter is kept clean or replaced regularly with the inlet air filter and the oil separation cartridge. But bearings, rotating at 1.450 rpm, 71.000 h long, after 6.177.000.000 revolutions, might need a tolerance and vibration control, which for safety reason, frequently motivates their replacement, as the air end is stripped only once every ten years.

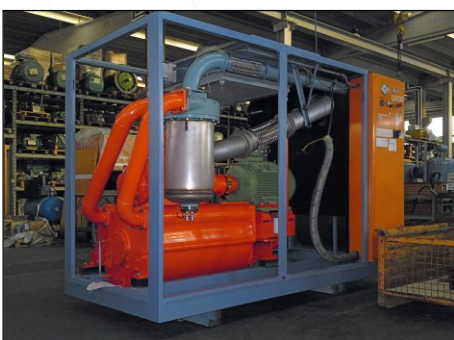
Reassembled UV30, totally revised, ready for testing

The overhauling work lasts few days only, then the unit is reassembled and tested in capacity, efficiency and noise. With a total cost of 10% of the new unit's list price, this total check and overhaul represents a guaranty for almost 10 more years of work. This minimal service cost contributes to have the lowest Life Cycle Cost compared to other technologies.
